NASA TM-78845

**IMPACT BEHAVIOR OF FILAMENT
WOUND GRAPHITE/EPOXY FAN BLADES**

by Kenneth J. Bowles
Lewis Research Center
Cleveland, Ohio 44135

TECHNICAL PAPER to be presented at the
Twenty-third National SAMPE Symposium and Exhibition
Anaheim, California, May 2-4, 1978

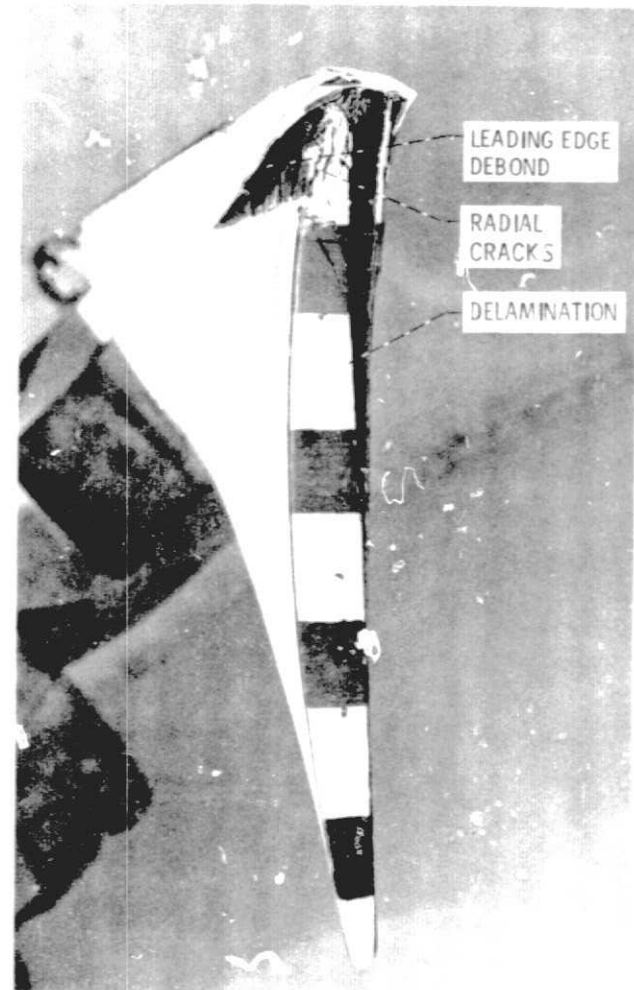
During the calibration of the simulated bird injection apparatus prior to the 22° impact test, the leading edge of blade FS-3 accidentally struck the bird injection apparatus stand. Some damage was sustained by the blade. Radial cracking of the spar near the leading edge (Fig. 7), shell debonding (Fig. 7) and leading edge protection sheath debonding (Fig. 8) were evident. Visual examination of the blade and tap tests (hand tapping at several span locations with a hammer) indicated that the damage was confined to the upper 20 percent of the blade span and the test was continued.

The blade was sectioned and examined with dye penetrant. The results can be seen in Figure 13. Insets A and B show the blade tip and a section through the area of impact. Some radial cracking of the spar is evident. These cracks, when compared to the cracks shown in Figure 7, appear to be caused when the blade accidentally struck the injection apparatus stand prior to testing. No significant local damage was revealed

Figure 7. - Blade FS-3 after striking bird injection apparatus stand.

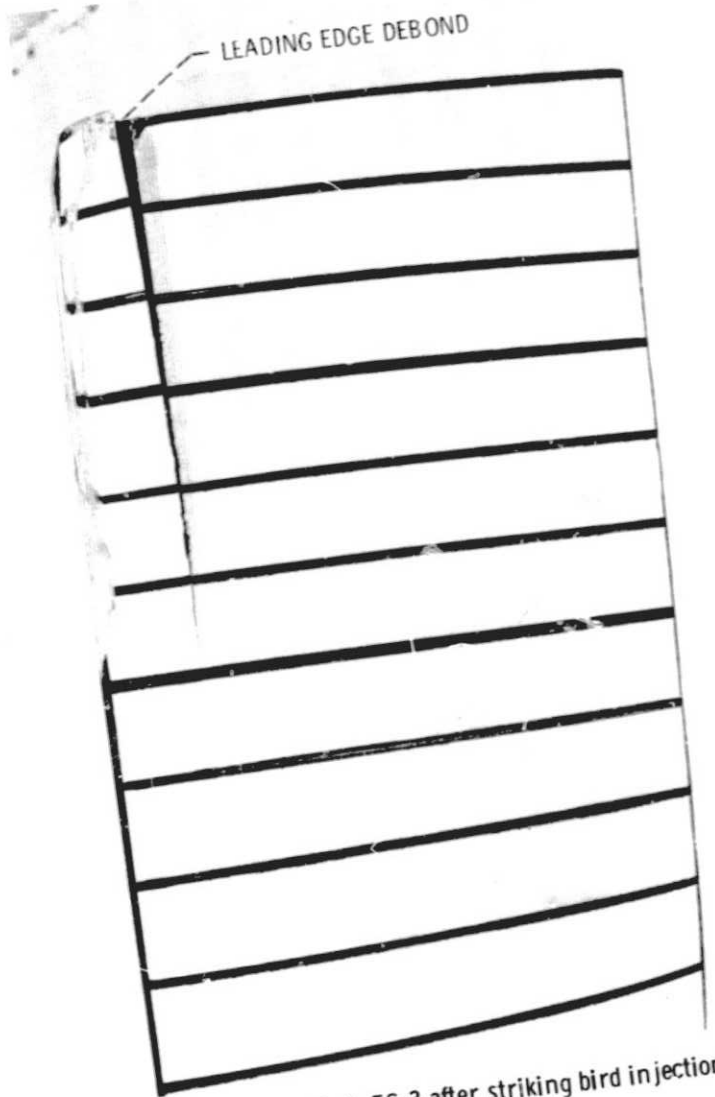
Figure 8. - Blade FS-3 after striking bird injection apparatus stand, suction side.

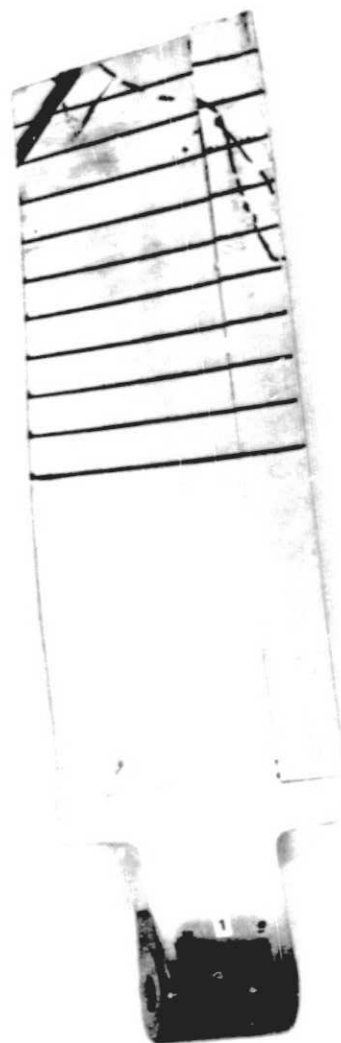
(a) BLADE FS-3 (22°)

Blade FS-3 was impacted at an angle of 22° with the simulated bird. The slice size was 449 gms. The blade remained intact after the impact. Figures 9(a), 10(a), 11 and 12 show the blade after the impact. When these figures are compared with Figures 7 and 8

It can be seen that the leading edge protection sheath completely debonded along the suction face of the airfoil but not the pressure side. The amount of radial cracking in the spar tip did not increase significantly. The delamination of the shell from the spar at the tip of the blade (line B-B, Fig. 12) is about 2.54 cm to the left of the dashed line (A-A) in Figure 12. This increase was about 5 percent of the airfoil pressure face surface. Visual examination of the blade root showed that some root damage also occurred. The fiberglass root overlay was debonded from the wedge shaped sides of the root and there were some tears in the fiberglass in the corners where the 15.2 cm airfoil chord joined the 7.6 cm wide root.

Figure 9. - Blade post impact condition, pressure side. Dashed line denotes boundary of initial delamination from accidental impact.

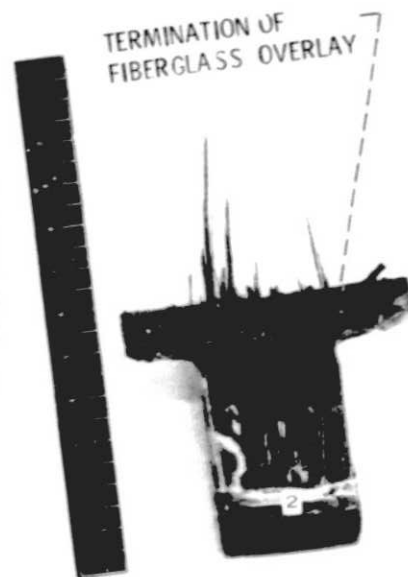
(b) BLADE FS-4 (32°)

Blade FS-4 was impacted with a 409 gm (0.916) slice of the simulated bird. As a result of the impact, the blade airfoil separated from the blade root (Figs. 9(b), 10(b), and 14) and impacted with the cell wall at a point 180° from the point of impact with the bird. Since the airfoil was pulverized by the impact with the cell wall, it was unavailable for sectioning. Figures 9(b) and 14 show the pressure face of the blade root after the impact. The fiberglass overlay was completely removed from the surface of the angled transition section. Spar fiber breakage extended to where curvature around the pin bushing begins, near the leading edge of the pressure side of the blade root. On the suction side of the blade root, all spar fibers broke where the fiberglass

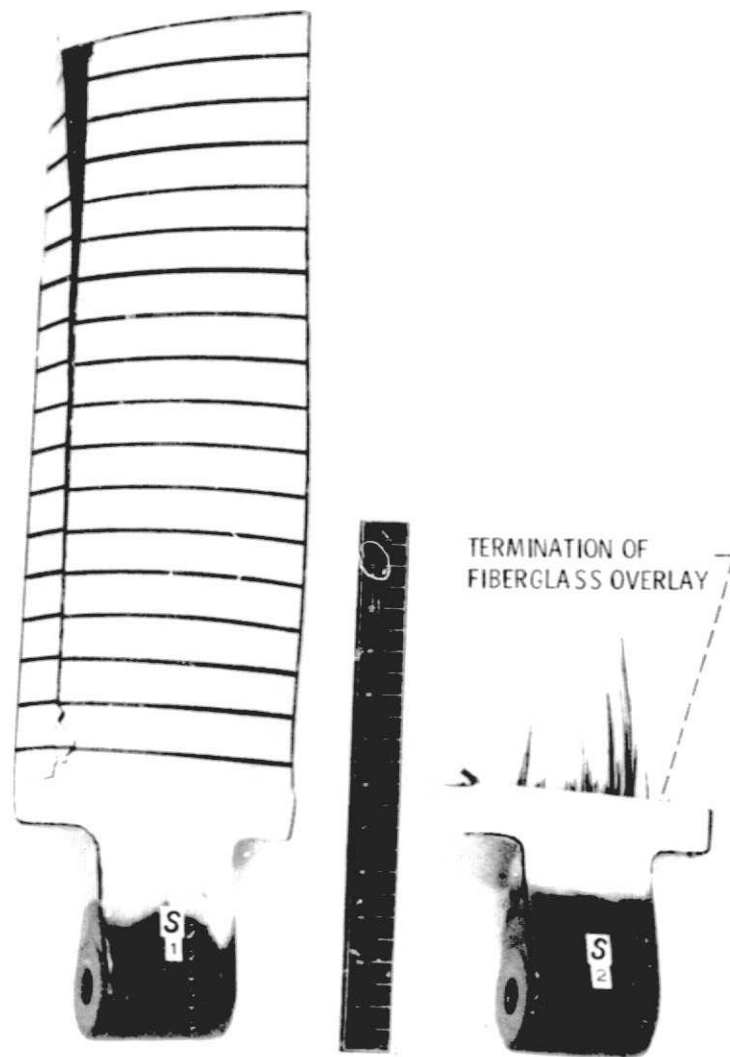
(a) BLADE FS-3 (22°)

(b) BLADE FS-4 (32°)

Figure 10. - Blade post impact condition, suction side.

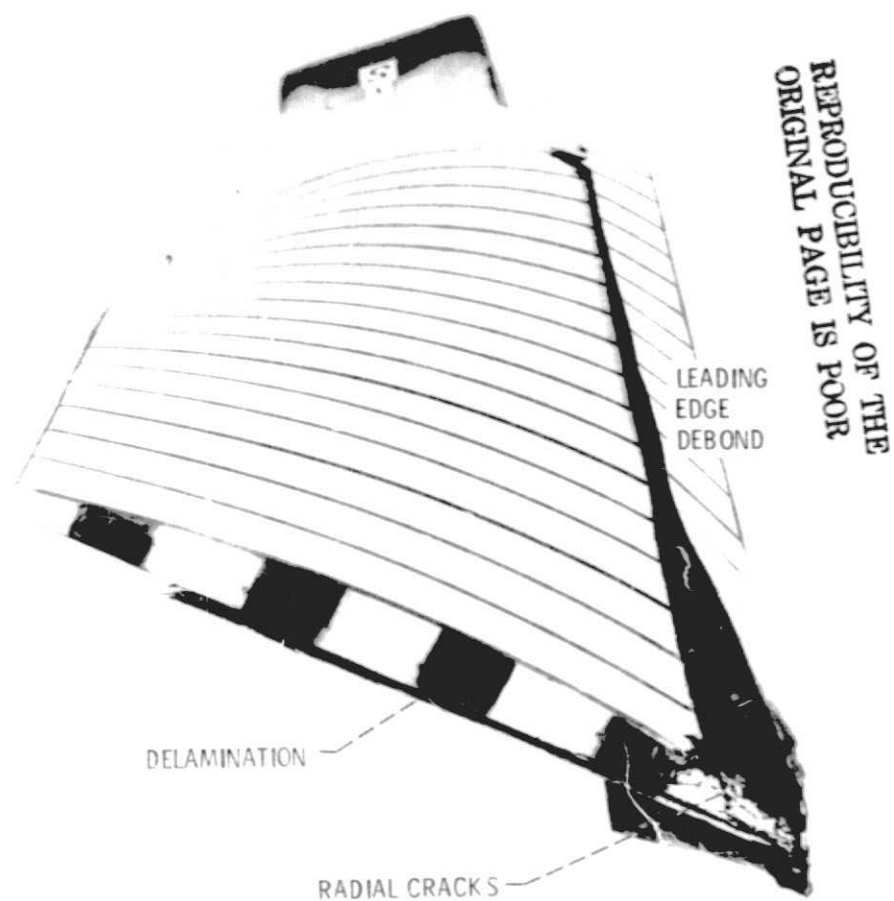
Figure 11. - Blade FS-3 tip post impact condition, 22° incidence angle.

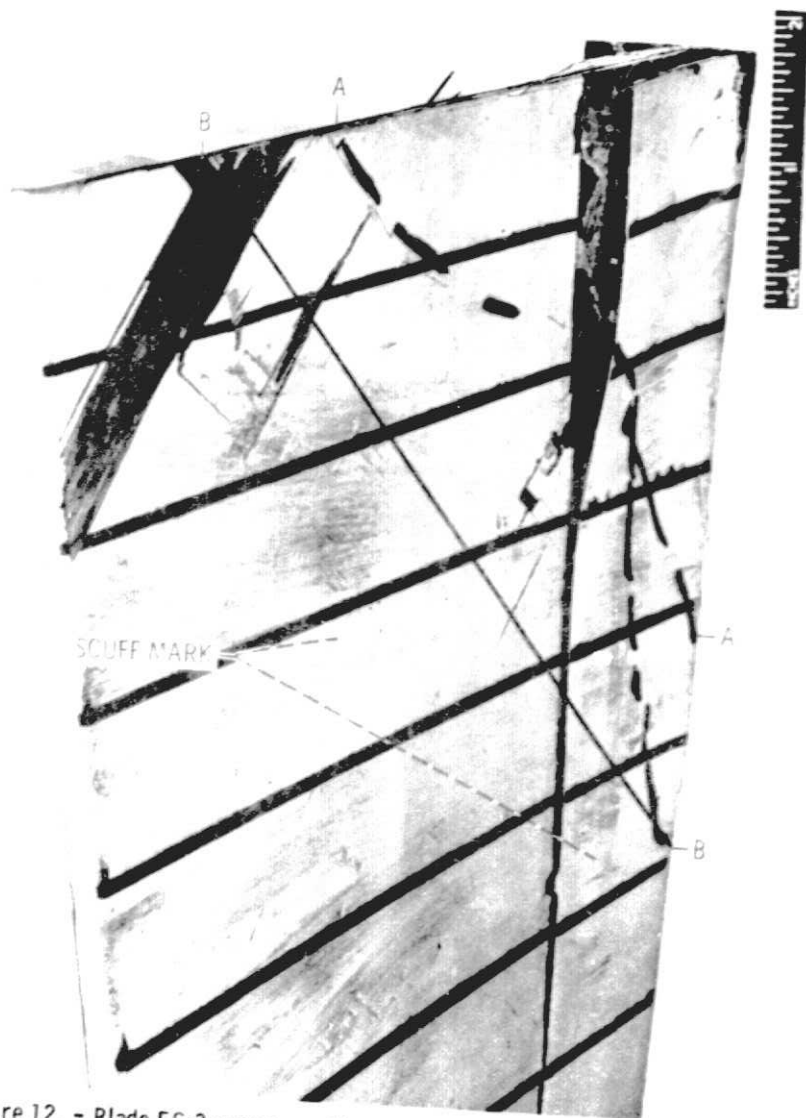
half of the blade and the other was against the trailing half of the blade. Evidence of two such heavy impacts can be seen in Figure 12. Two darkened scuff marks are visible on the surface of the blade. One is near the leading edge and the second extends along most of the trailing half of the blade. Blade tip angle measurements and times of measurement are presented in Table 1.

Figure 12. - Blade FS-3 pressure side post impact condition, 22° incidence angle. Line A-A is extent of delamination after accidental impact. Line B-B is extent of delamination after impact with bird.

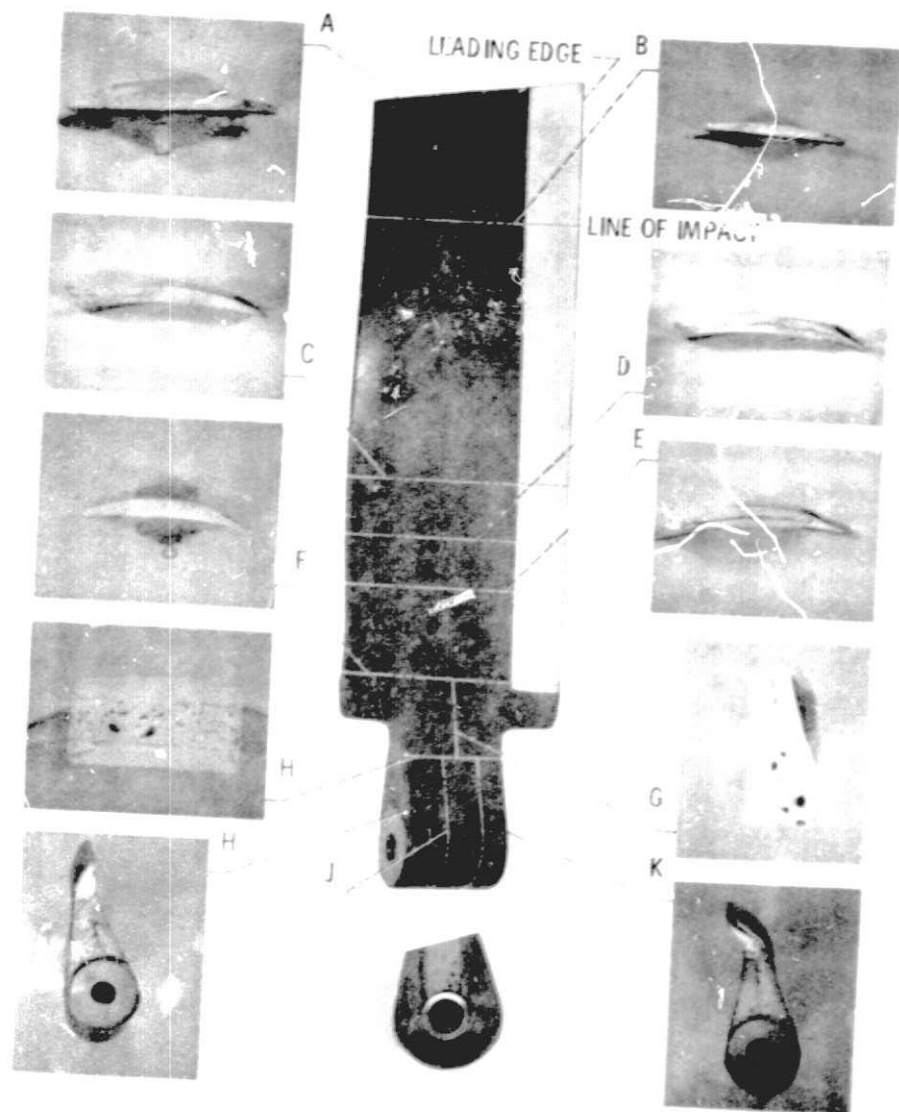
Inset C of Figure 13 reveals the first example of blade damage caused by the simulated bird impact. A shear type of crack can be seen near the trailing edge of the blade. Progressing down the blade (insets D, E, and F) it can be seen that the crack lengthens across the chord of the blade. Also, radial cracking of the spar is evident. Insets G, H, J, and K show that the crack extends down into the root of the blade.

The impact of blade FS-3 with the simulated bird at an angle of 22° was sufficient to initiate some damage in the root area of the blade. The damage is shown in Figure 13

(insets D, E, and F) and consists of what appears to be a shear failure at the neutral axis of the blade spar. The blade twisting alone did not cause this failure.

Figure 13. - Sections of Blade FS-3 after 22° impact.

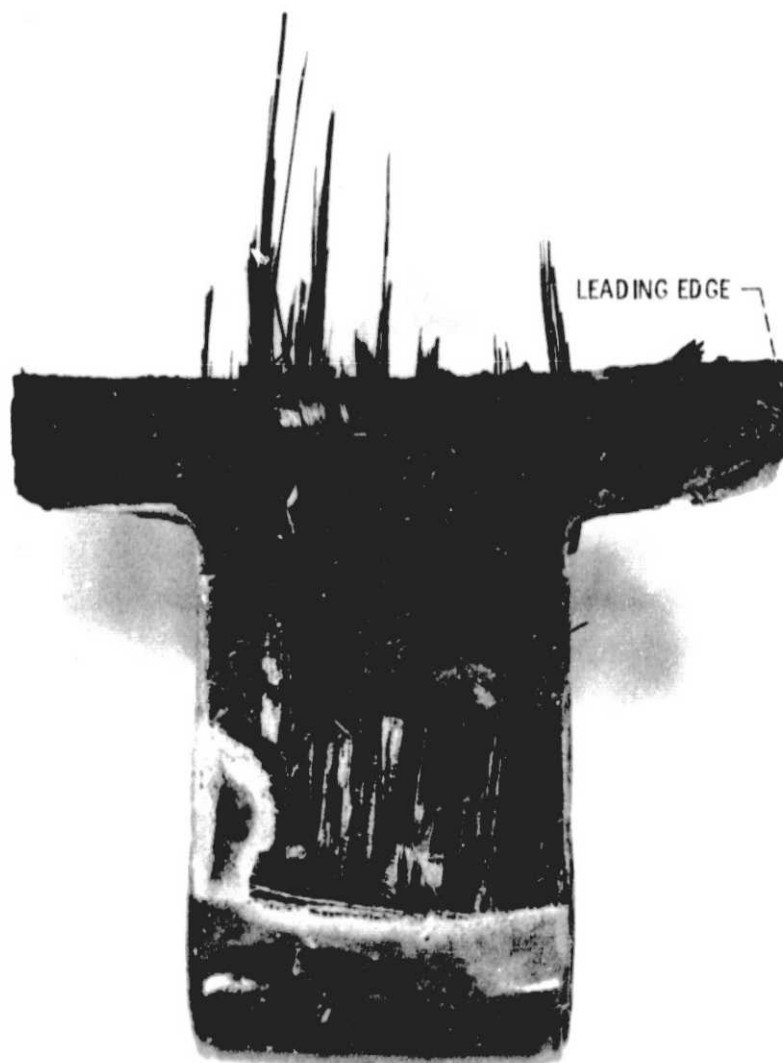
overlay terminated on the lower part of the airfoil.

Examination of the root transition area revealed that approximately 33 percent of the spar fibers that were wound around the bushing were ineffective. The fibers were cut during the root trimming step of blade fabrication because they had not been properly positioned. The cutting of the fibers significantly reduced the load bearing capacity of the root section.

Figure 14. - Pressure side of root section of blade FS-4 32° incidence angle.

The wrap around plies of fiberglass fabric used in building up the root, while strengthening the root against tensile forces, did not increase the resistance to shear or transverse tensile loading. Fabric oriented parallel to the longitudinal spar filaments through the thickness of the root could possibly increase the shear and transverse ten-

sile strengths in this area. While the blade airfoil was completely encased within a $\pm 45^\circ$ shell of wound fibers, the root area was not. The $\pm 45^\circ$ fibers covered only the suction and pressure faces of the root. The wedge shaped sides were trimmed after curing and the angled fibers were cut away. Epoxy impregnated fiberglass was wrapped over the root area to provide reinforcement, but the fiberglass tore at the sharp corners in both impact tests. The glass reinforcement may have been more effective had these corners been rounded.

A more positive method of aligning the spar fibers in the root area would assure that the fabricated blade root would possess the actual strength it was designed to have. A fabrication process should be developed which does not require trimming in the root area so that both the radial strength of the spar fibers and the torsional strength of the shell fibers could be utilized in the root.

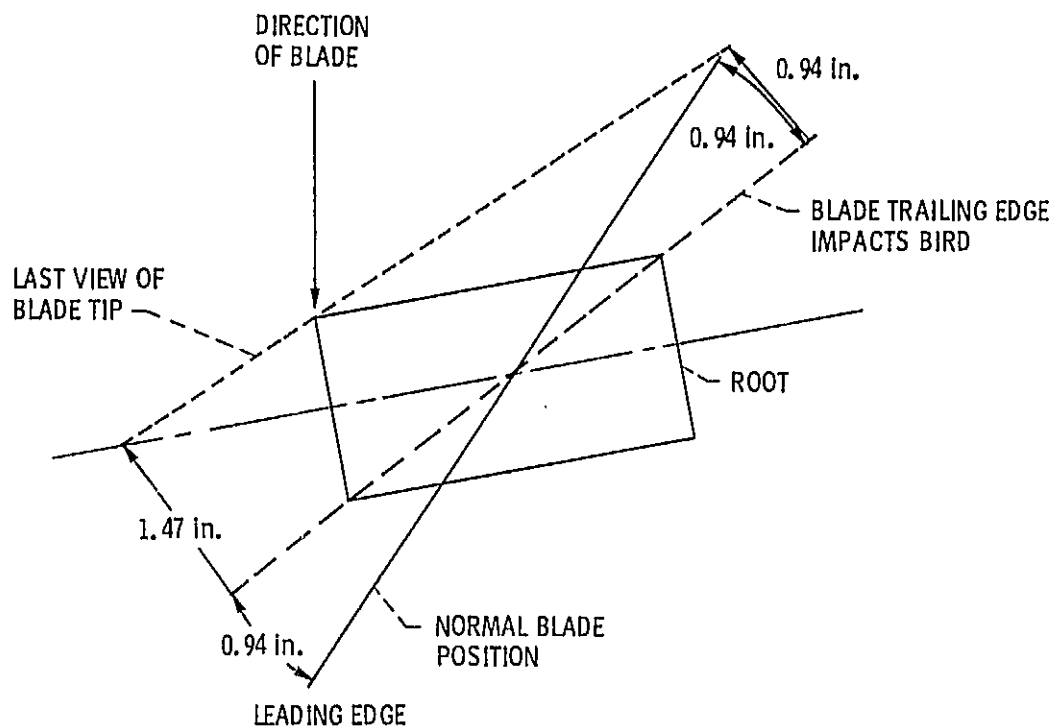
Analysis of the motion pictures showed that blade FS-4 experienced the same chordwise twisting as blade FS-3. The data are shown in Table 2. Figure 15 shows a schematic description of the reaction of the blade tip to the impact. All views are superimposed on the same reference plane. The solid tip outline indicates the position of the blade tip as the blade was about to contact the bird. The dashed tip outline shows the position of maximum twist of the blade tip that occurred at the time the trailing edge of the blade impacted the simulated bird. The dotted tip outline indicates the position of the blade tip as it was leaving the viewing area of the camera. The first impact (leading edge) started the blade twist-

ing. The second impact stopped the twisting but did not reverse it as with blade FS-3. Instead of a reverse twist, the blade bent backwards with the leading edge fibers having been strained much more severely than the trailing edge fibers.

Figure 15. - Reaction of blade tip of FS-4 with simulated bird at 32°.
